Analysis of roof windows

The company VELUX develops and produces roof windows, as well as modular skylights, blinds, shutters and ventilation systems. In order to continuously raise the product range and quality, VELUX is not only engaged in improving the production process, but also the individual materials used in the products. Exterior window components such as the installation components are exposed to significant mechanical deformation during processing and installation as well as harsh climatic conditions during service life on the roof. This leads to very high requirements on materials used as well as manufacturing processes.

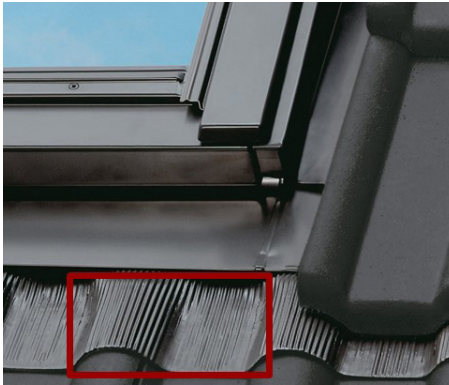
Wavy structure of the studied window part.
